**US Army Corps
of Engineers**

USACERL Technical Report 99/28
February 1999

Engineering Life-Cycle Cost Comparison Study of Barrier Fencing Systems

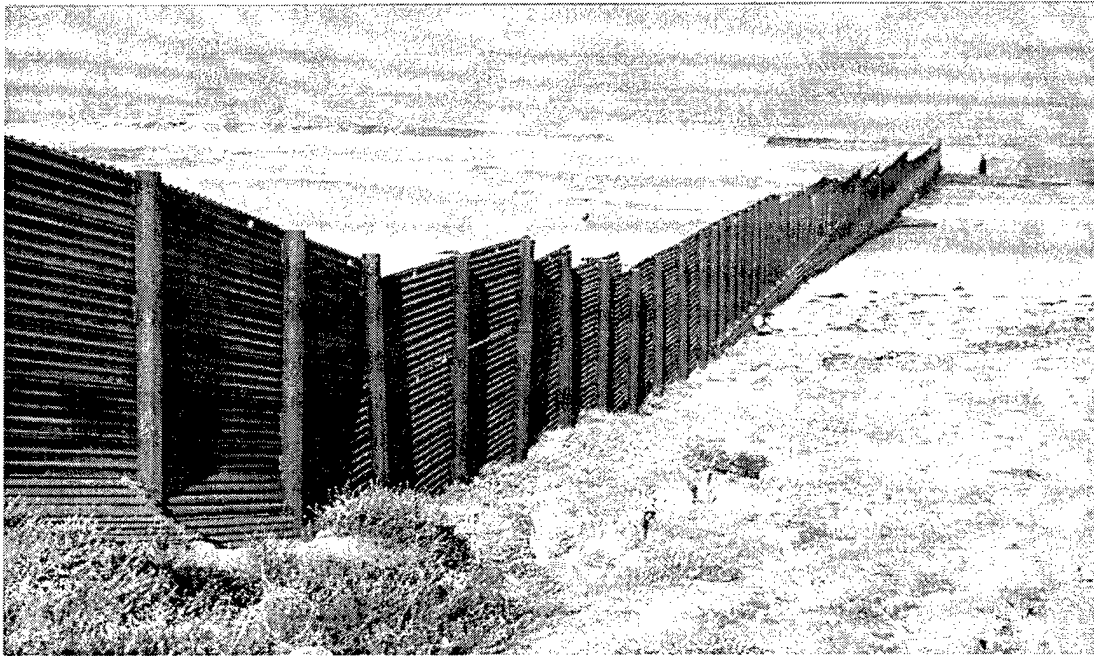
Figure 1. Landing mat design barrier.

The landing mat fence (shown in Figure 1) is one of the few designs where significant long-term experience has been gained for its application. Although its installation was an impressive effort in response to the mission needs of the Border Patrol, the benefit of functional experience offers some lessons learned. An initial lack of detailed design, construction procedures, and performance requirements has resulted in problems. These problems include:

- inadequate footings for the terrain, loads, and soil conditions involved
- lack of provision for thermal expansion
- inadequate corrosion protection
- lack of dig-under prevention
- inadequate resistance to mechanical attack
- inadequate barrier to quick re-entry into Mexico to avoid apprehension (a Border Patrol operational requirement).

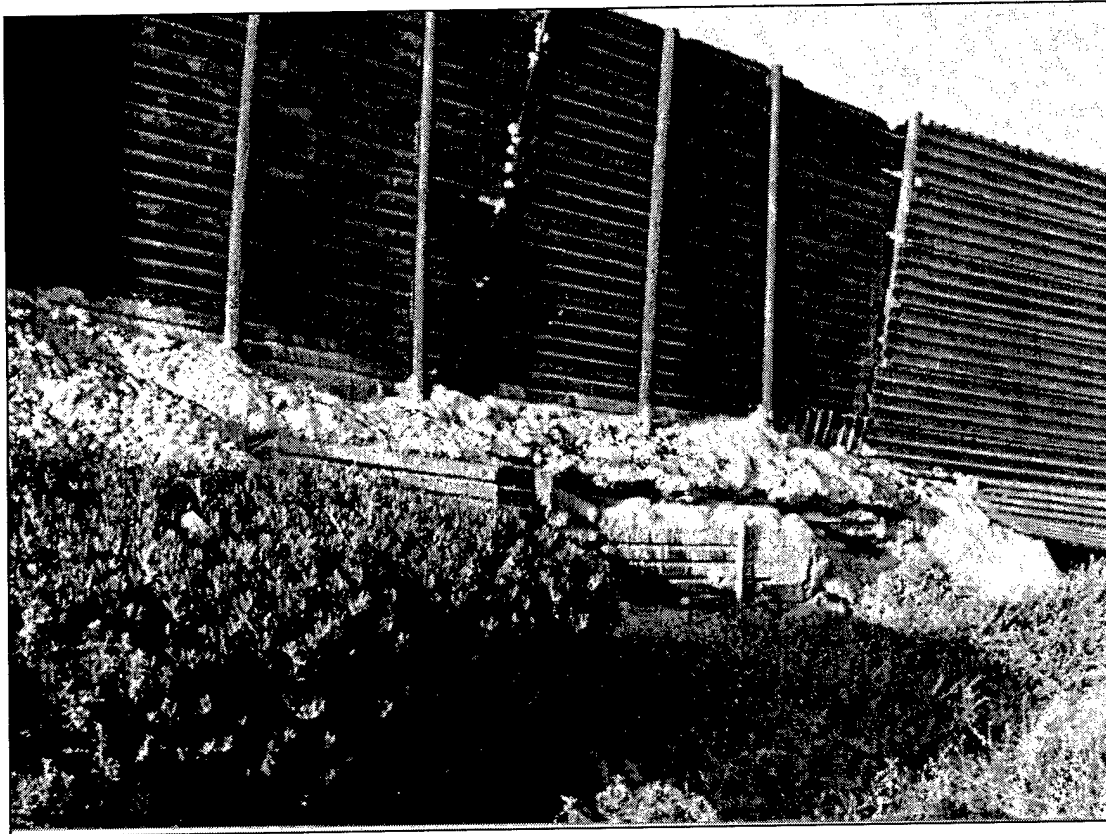
Figure B.4. Concrete poured into holes under the fence as a result of dig-under breaches and erosion of the loose beach sand.

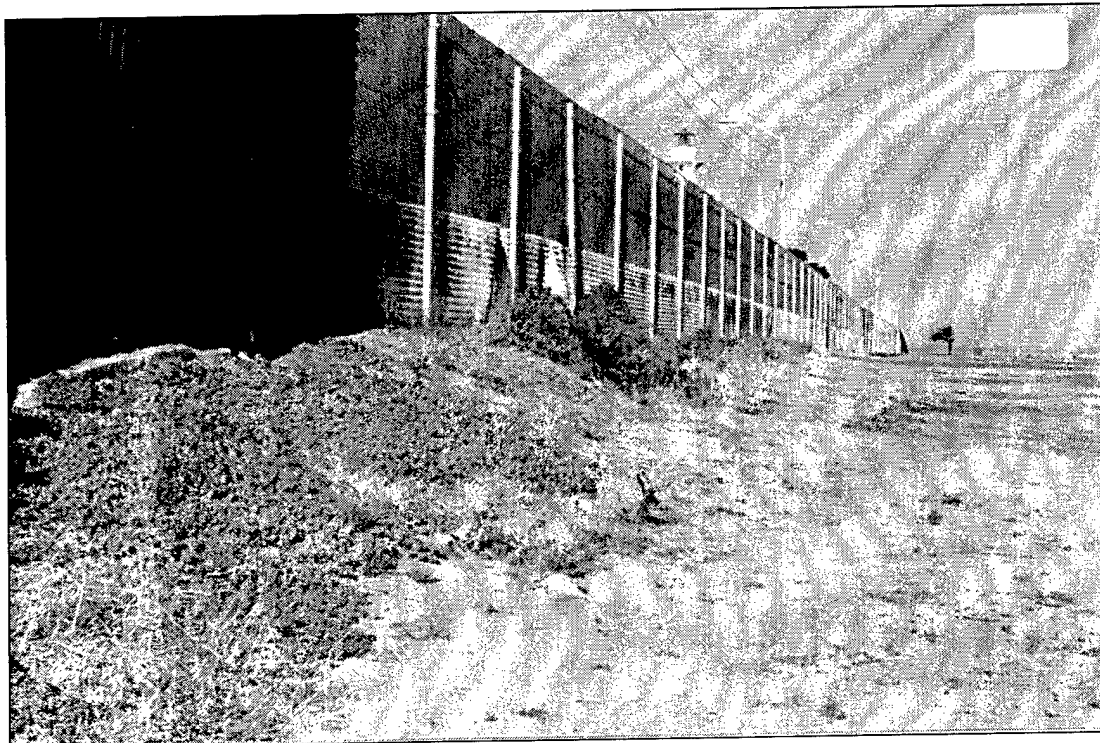
On the top of the embankment is a chain link fence. Figure B.5 shows the fence to be approximately 100-yd long. At the far end of the picture is the ocean section of the primary barrier, and in the foreground is the beginning of the inland landing mat fence. Figure B.5 shows the 2- by 3-in. channel bar used for support poles for the diamond mesh bottom and wire-link top. The fence is 10- to 12-ft tall with poles 6-ft apart, embedded in concrete. Most damage is from holes cut in the wire-link portion of the fence. Repairs are crude patches of fence or, as shown in Figure B.6, rebar secured in the opening by wire and rope. The Tijuana bullring is approximately 50-yd south of this fence.

Figure B.5. Chain link fence connects the ocean fence and the first inland section of landing mat fence.

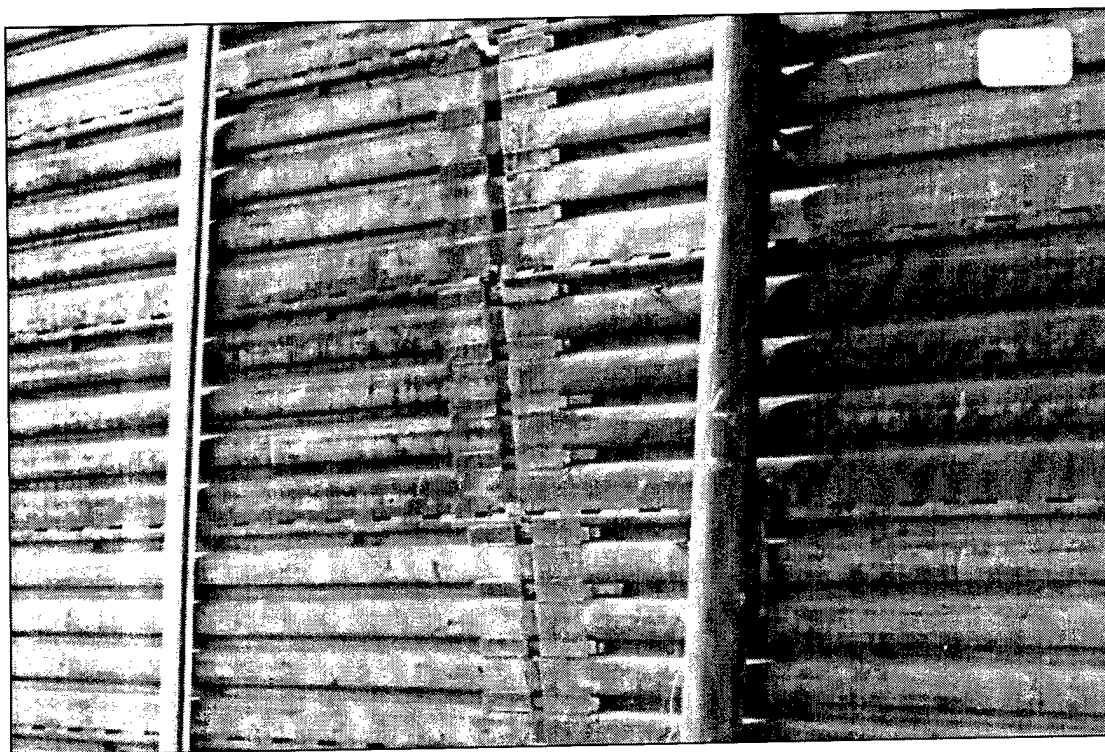
Figure B.8. Mats still have paint only 700 ft inland, and sections are connected by square pins and welded to vertical pipes.

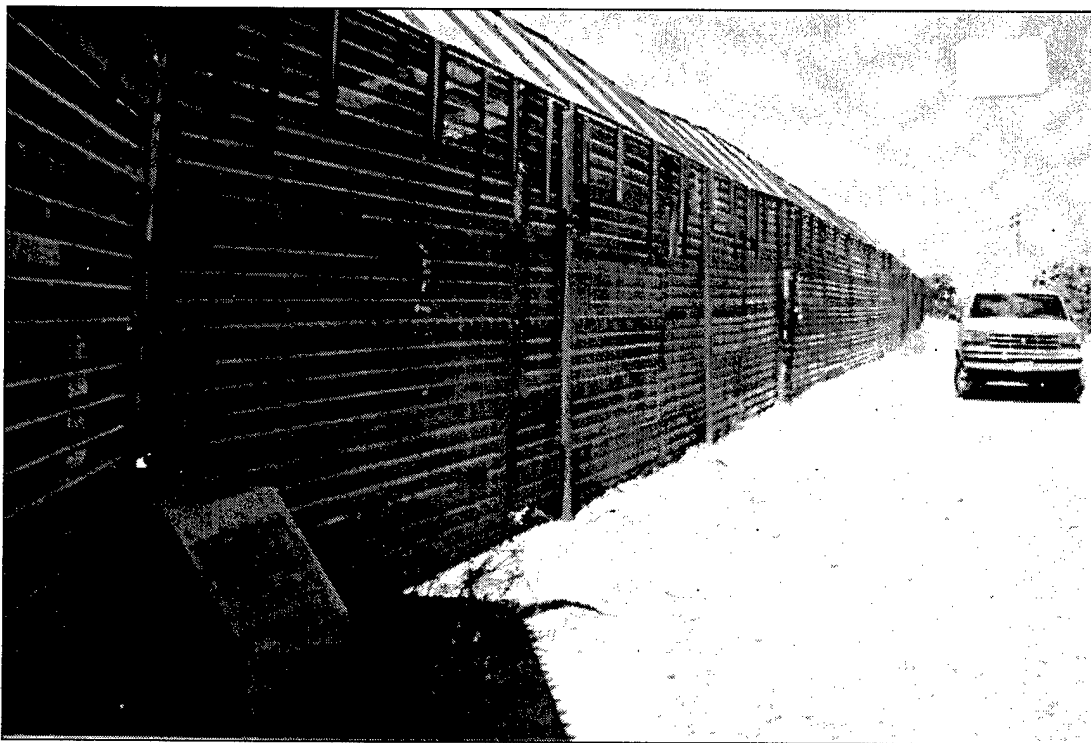
The Tijuana levee is east of the sewage plant. The fence borders the levee and extends past the old truck entry point to the San Ysidro border entry point. The area shown in Figure B.16 is another high traffic area where the BP has rein-

forced the fence. Angled extensions have been added to the top of the fence making it well over 10-ft tall. The support poles for the fence are 3.5-in. diameter pipes (not the well casings) that are welded to the mats only at the end of the pipe. The poles are positioned nearly 12-ft apart on center, which is not sufficient to properly support the weight of the landing mat sections. The pole behind the monument is only 2.5 in. in diameter, which is inadequate to support the weight of the fence. The sections are seven panels high, weighing approximately 1,260 lb. The ground along the levee is firm, so poles have a stable footing. The fence extends from the levee monument down a small hill to the old U.S.-Mexico truck entry point shown in Figure B.17. The secondary landing mat fence starts behind the BP vehicle parked in the shade west of the old gate. The fence runs parallel to the primary barrier. Figure B.18 shows the additional deterrents added to the secondary fence, which is six panels high with two panels in the overhang. Two-ft wide sheet metal is attached to the fence about 5-ft above the ground. In addition, the overhang is capped with 6- to 7-in. diameter PVC pipe, which does not allow anyone climbing the fence to grip the top. The secondary fence appears rusted but not damaged.

Figure B.16. Fence along the Tijuana levee.

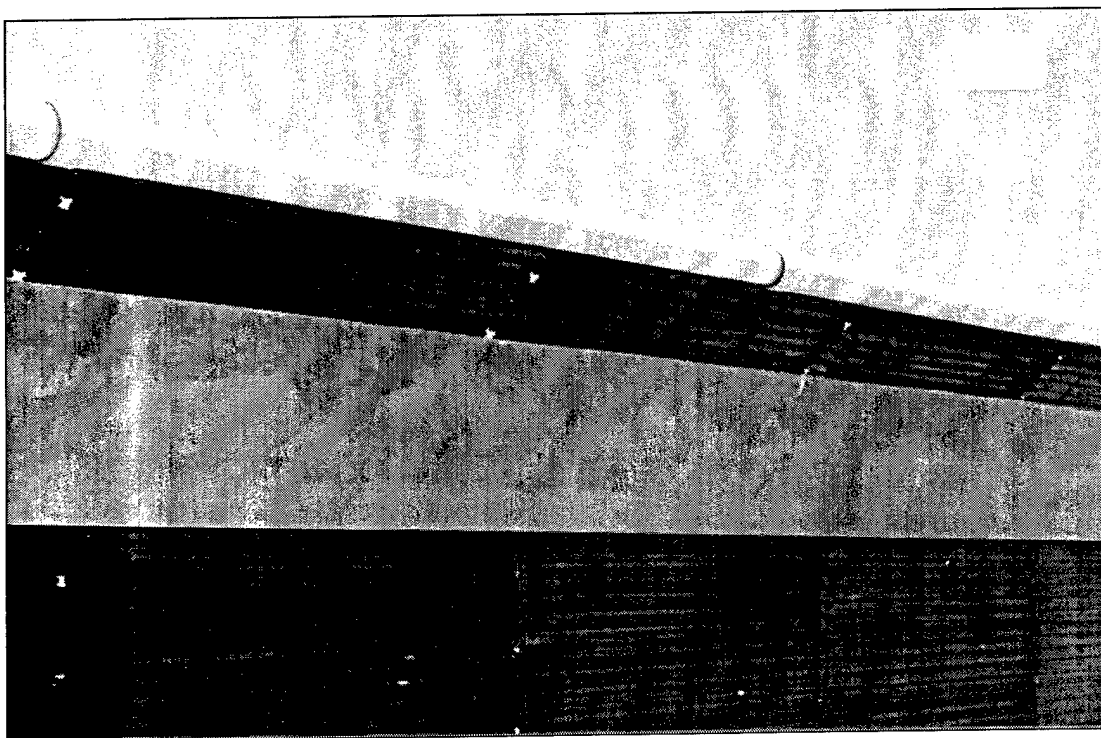
Figure B.18. Secondary fence in the section west of the San Ysidro border entry.

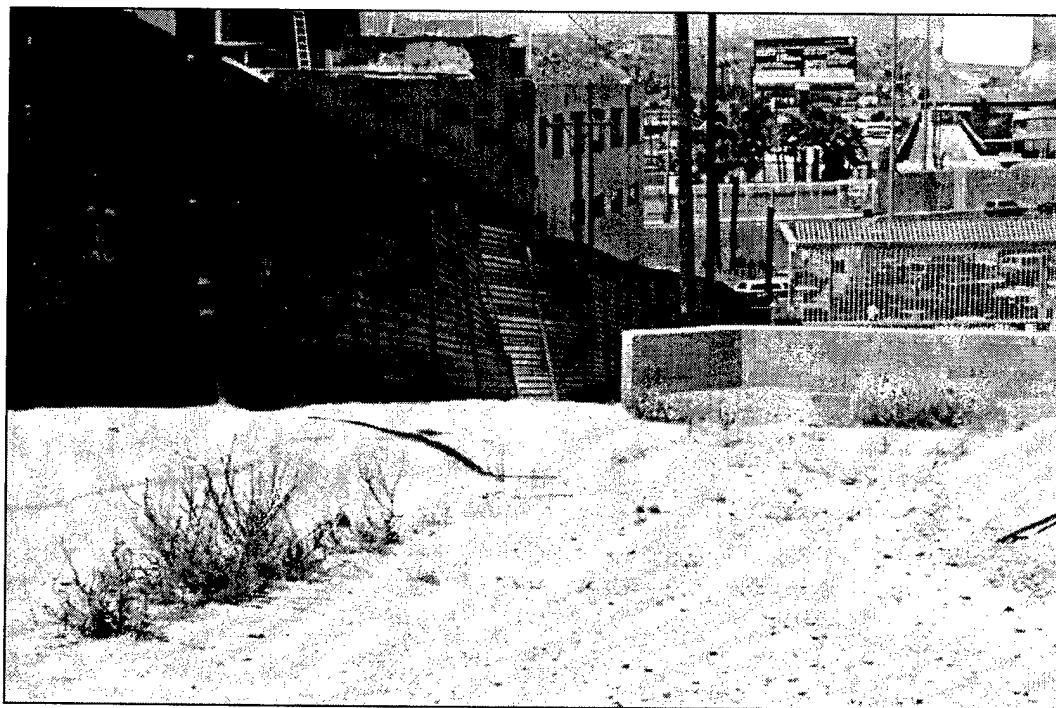
The fence shown in Figure B.19 begins east of the San Ysidro border entry point. The other side of the brown vertical bar fence is Mexican territory. The fence is supported with 2-by-2-in. I-beams embedded in concrete. The concrete reinforcement of the fence bottom with wire mesh inserted into the ground. The I-beams are approximately 10 ft on center and about 8.5-ft aboveground. The deformation in the fence shown in Figure B.19 has resulted from pulling on the fence. The sheared I-beam at the bend indicates that the I-beams are insufficient to support the fence. The panel surfaces have small amounts of corrosion with some of the original paint still intact. The fence extends from the border entry point east to the hilly terrain shown in Figure B.20. Note how close the dwellings on the Mexican side of the fence are to the primary barrier. The hills precede a large stretch of fairly flat ground that is a high traffic area for illegal crossings. The flatness of the ground is shown in Figure B.21. A large highway south of the fence leads to the Tijuana Airport. Figure B.21 shows repairs made to the fence after an accident with a semi-truck on the Mexican highway. The truck bent a section of fence, but the BP was able to bend the damaged pole back to support the panels and maintain the integrity of the fence.

Figure B.19. Fence east of the San Ysidro border entry point.

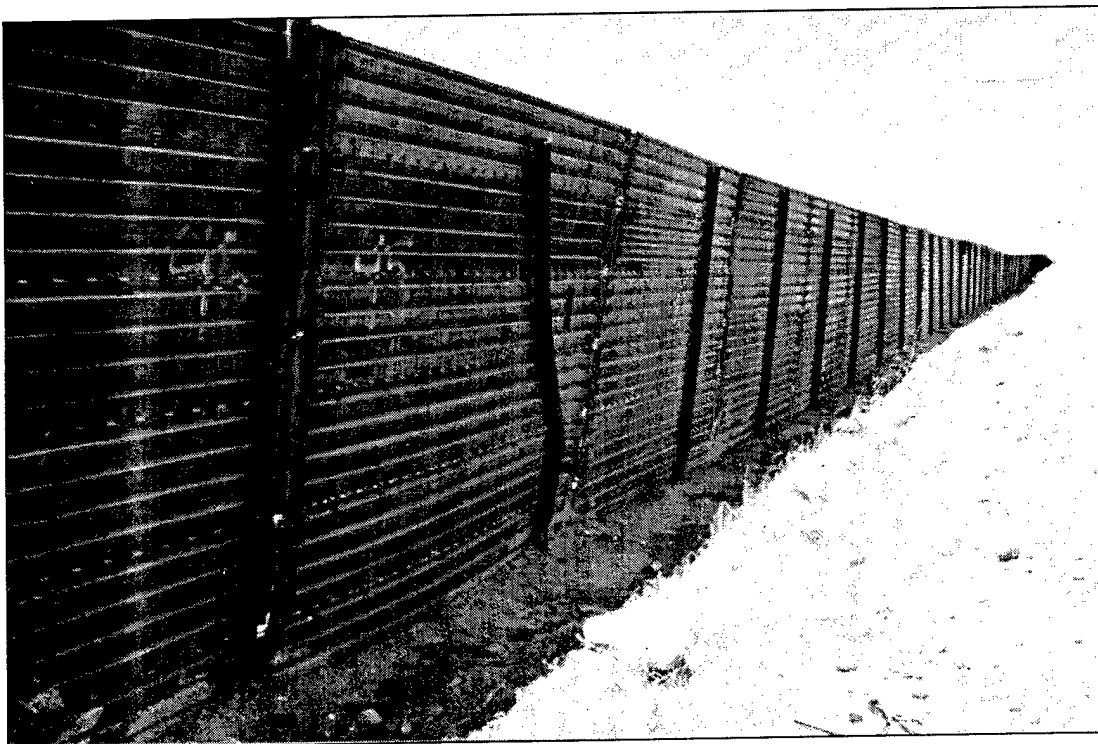
Figure B.21. Fence running between the hills and the Tijuana Airport is repaired from a truck collision on the Mexican side.

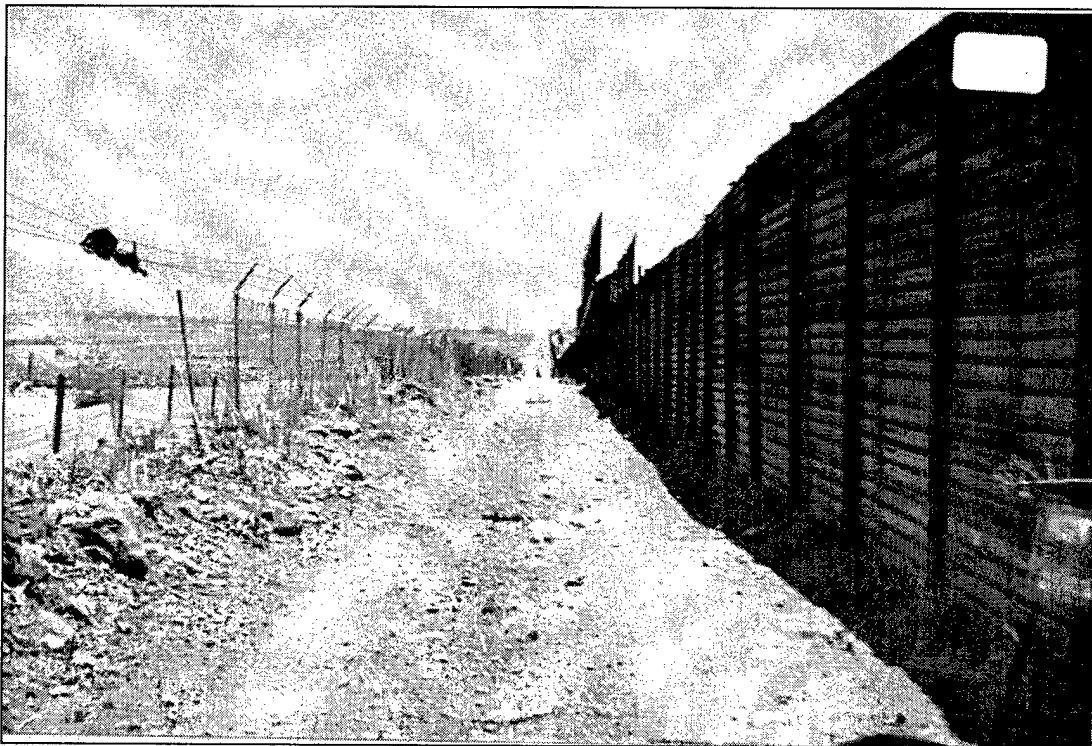
Figure B.22 looks east over the flat landscape preceding the Otay hills in the distance. The soil composition is still loose and sandy, making digging under the fence easy. The 8.5-ft height of the fence makes climbing over the fence easy also. An illegal alien is surveying the ground in the distance. If the BP were to approach him, the alien would just hop back over the fence. The billboards rising above the fence are next to the Tijuana Airport. The chain link fence just 10 to 12 ft north of the primary fence borders private property. The fence has been damaged by heavy traffic, and sections of it are completely gone. Trash from Mexico is also visible. About 1 mile east of the Tijuana Airport and 1 mile west of the Otay truck border entry point is the installation site for the secondary Sandia fence. The Sandia fence is roughly 120 ft north of and parallel to the primary fence.

Figure B.22. Looking east along the fence toward the Otay hills.

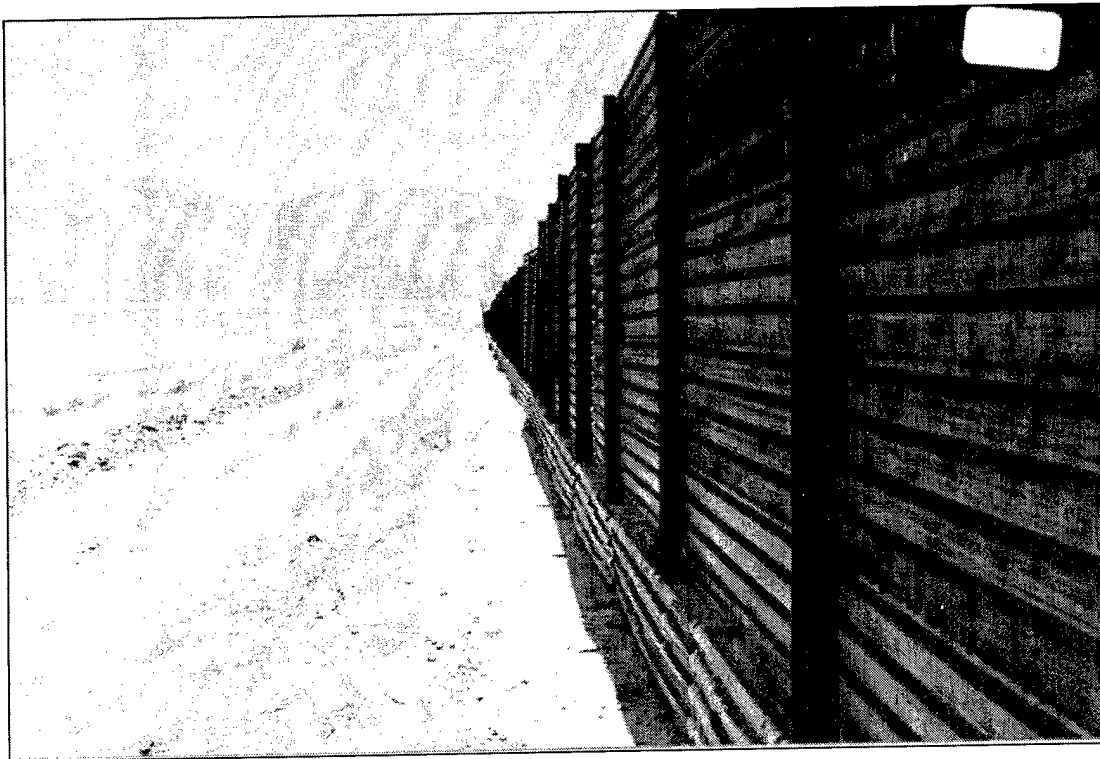
Figure B.23 shows the fence on the level terrain east of the Otay truck border entry. This area of primary fence has been reinforced at the base with additional landing mat inserted into the ground and concrete. This reinforcement method appears to work very well in preventing dig-under breaches and solidifying the pole supports in the loose soil. There are no major bows in the fence alignment and much of the original paint still exists on the mats. Damage to the fence has been more aggressive in this area of the border. Figure B.24 shows damage to the fence made by cutting and/or disconnecting the panels. Repairs were made by welding a horizontal pipe between vertical supports. The far east part of the fence has not been reinforced with concrete. Figure B.25 shows the result of attacks on this part of the fence by car ramming. The panels toward the top of the fence were separated by the ramming, but the fence did not collapse from the impact. Note that the connections between landing mat sections are welded rods between sections and an additional panel behind the poles without concrete. The sturdiness of the well casings as support poles and the landing mat panel as a primary wall was verified in this incident.

Figure B.23. Flat region of fence east of Otay truck entry point.
